DOT/FAA/CT-93/78
DOT-VNTSC-FAA-93-10

FAA Technical Center
Atlantic City International Airport,
N.J. 08405

Full-Scale Testing and Analysis of Curved Aircraft Fuselage Panels

Final Report

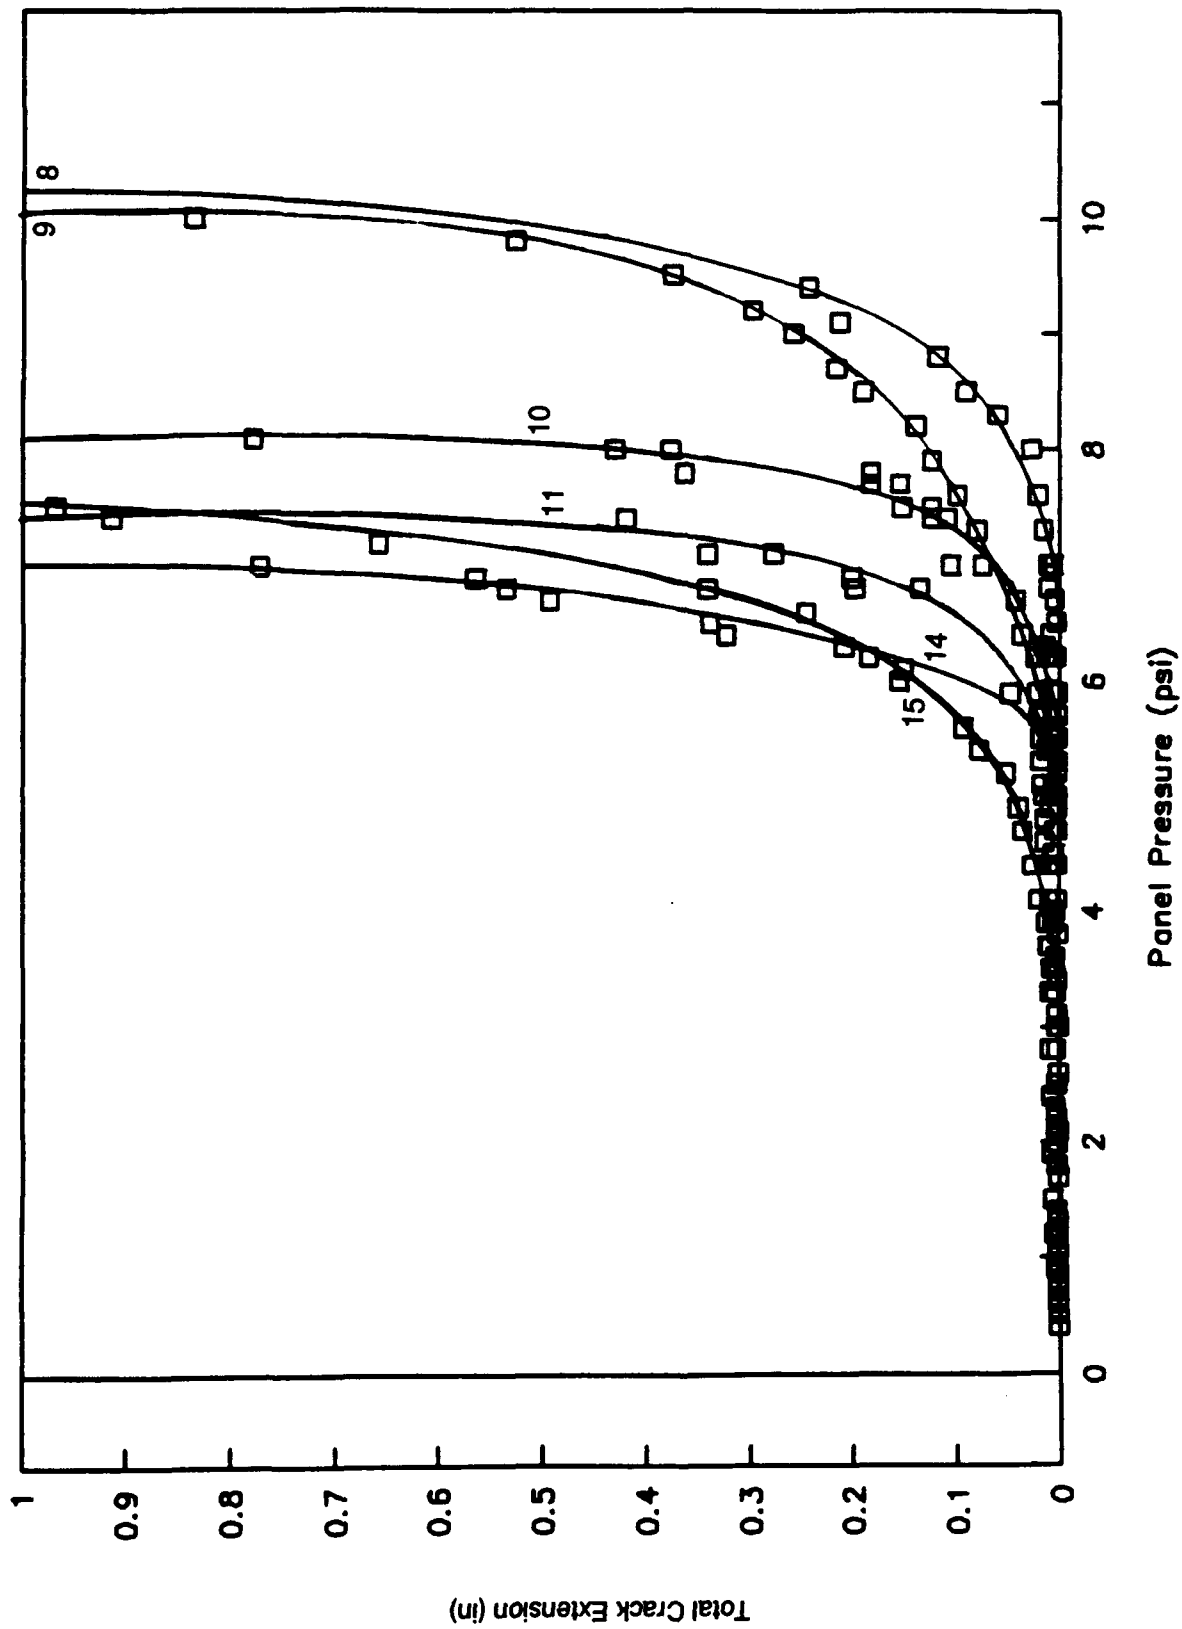
Figure 7. Crack Propagation in Residual Strength Tests

Test data and correlations with analytic predictions follow. The residual strength is expressed in terms of panel internal pressure at the onset of fast crack growth. Hoop and longitudinal stresses were measured with strain gauges. Crack propagations in the first ligaments beyond the lead crack tips were measured with an indirect DC potential drop system. The relationships between crack propagation and applied pressure are shown in Figure 7. The following subsections discuss the results of each test.

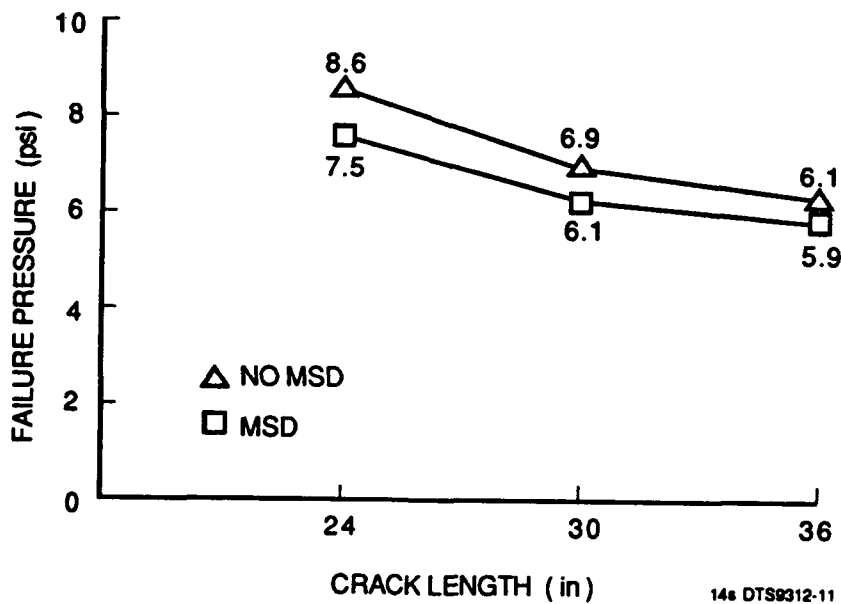
Figure 27. Panel Residual Strength

The residual strengths (failure pressures) for the test panels were shown in Table 5. The relationship between failure pressure and lead crack length is shown in Figure 27. The strength reduction due to MSD can be related, by an elementary analysis, to the area of the first

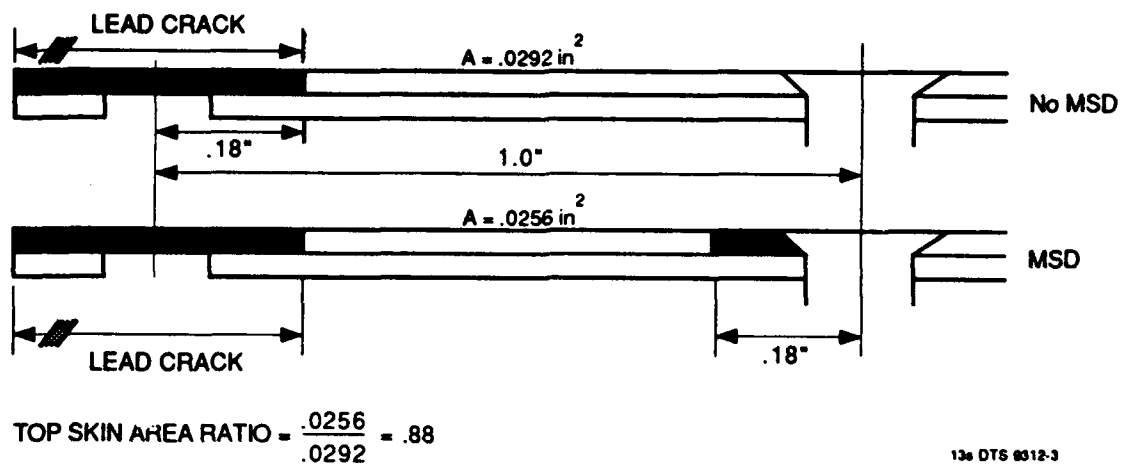
Figure 28. Crack Tip Ligament Net Section Areas

ligament beyond the lead crack tips. The net section areas for the with and without MSD conditions are shown in Figure 28. The area ratio of 0.88 compares well with the failure pressure ratios for the shorter lead cracks.

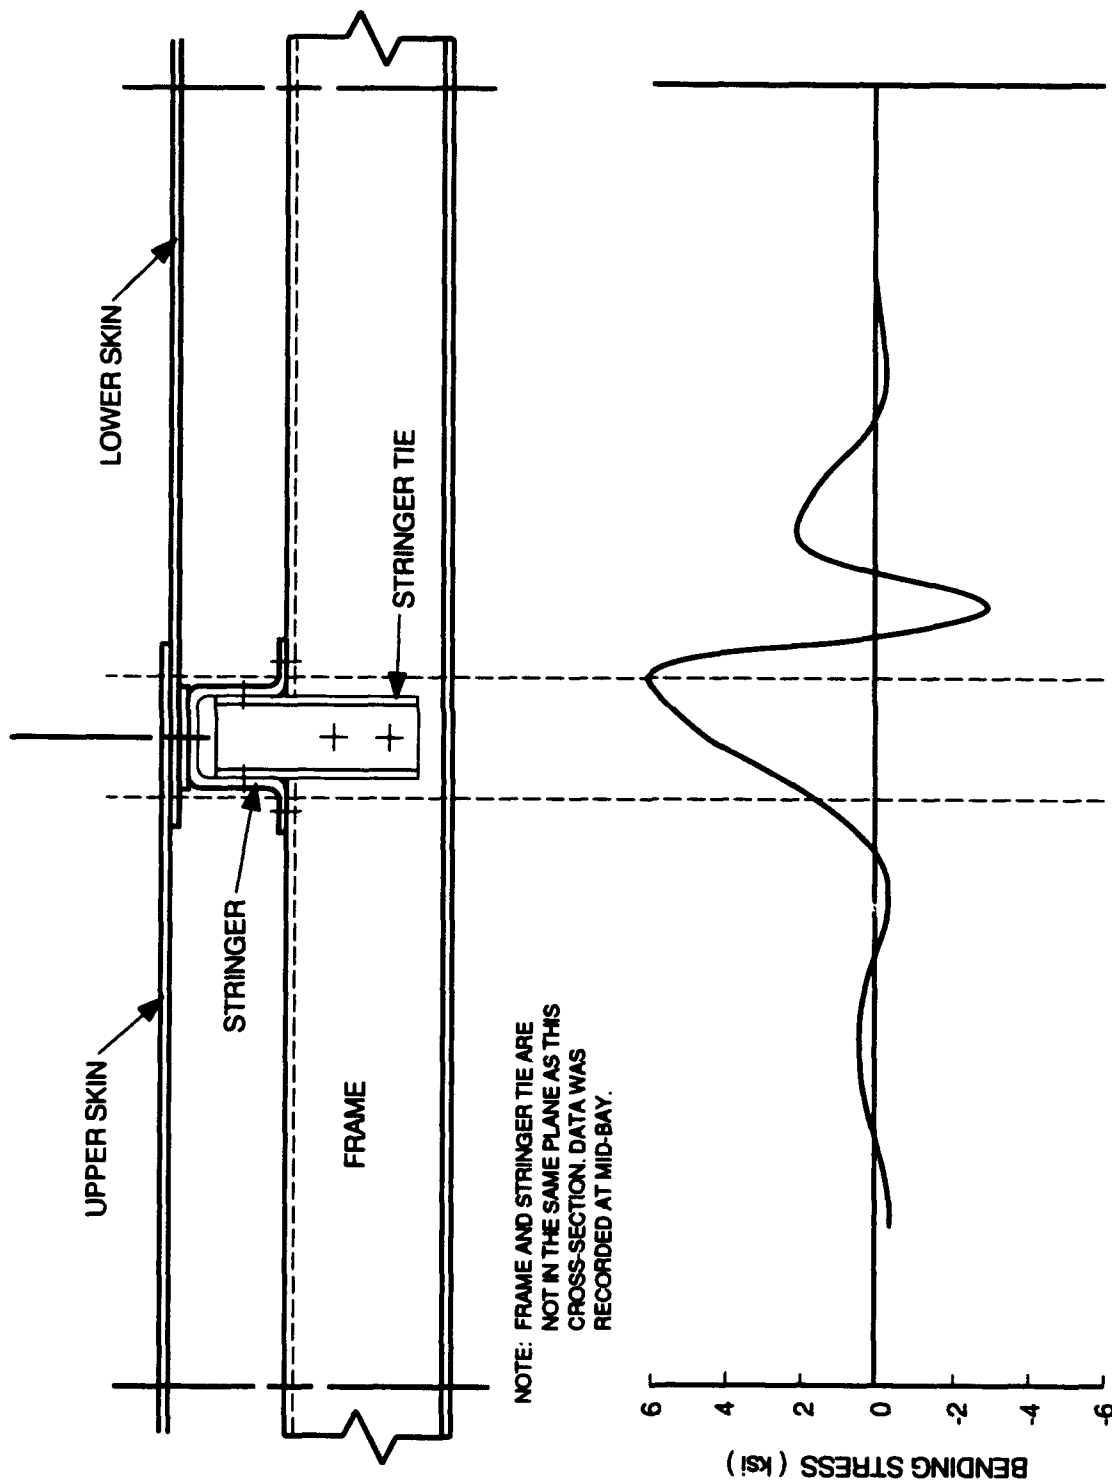
Figure 31. Bending Stress Distribution Across Lap Joint

The bending stress distribution across the lap joint is shown in Figure 31. Measurements taken from both the inner and outer skin surfaces indicated that the membrane stress in the hoop direction was consistently 14.2 Ksi at midbay. The distribution shown was measured midway between a frame and a tear strap. A positive bending stress defines a reduction in local panel radius of curvature and thus a higher outer surface stress. The figure shows that the bending is highest (~6 Ksi) at the lower row of rivets. This may be due in part to the fact that internal pressurization results in bending about the rivet line on the lower side of the lap joint and bending about the lower skin edge on the upper side of the lap joint. Characteristics unique to panel construction may contribute to this phenomenon.

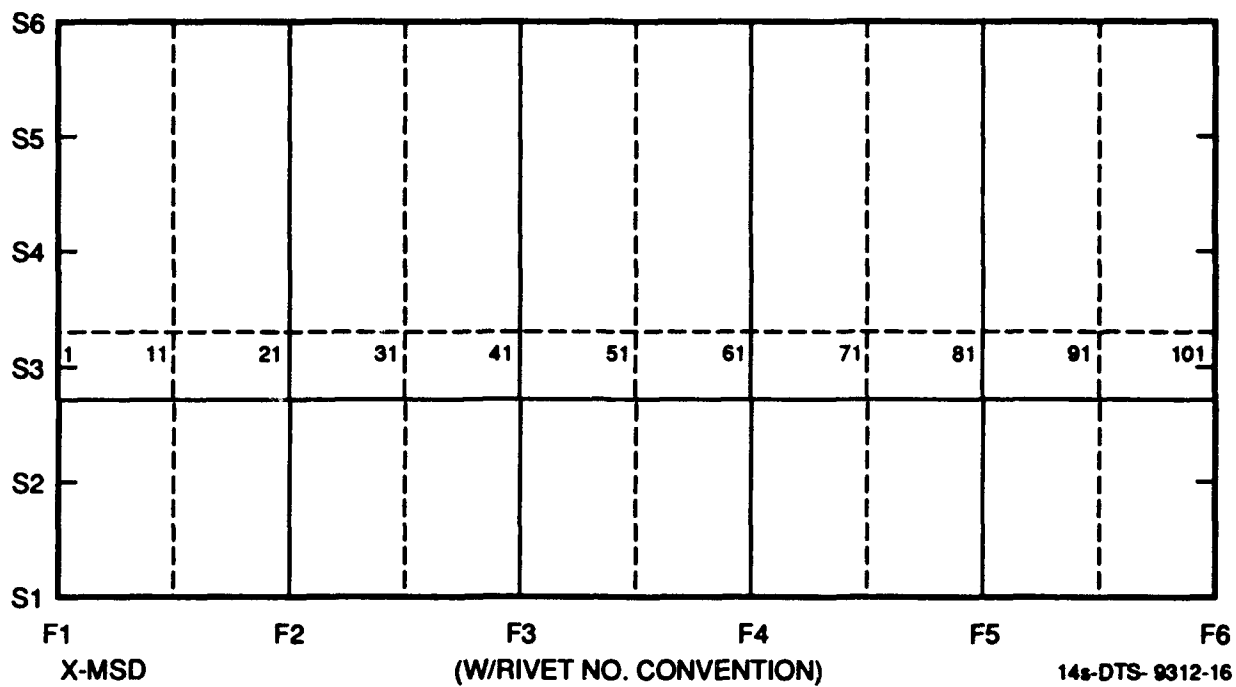
Figure 37. Test Panel No. 12 - Undamaged with Rivet Number Convention

The progression of test events is summarized in Table 6. For convenience in identifying damage locations, the rivet stations were consecutively numbered from F1 to F6 as shown in Figure 37. Damage to the numerically ascending and descending sides of the rivet are designated "+" and "-" respectively.

visible along the upper rivet row. At 114,571 cycles, lap joint leakage became pronounced. Upon inspection, link-up had occurred between rivets 35-37 on the lower rivet row. The panel fractured at 115,755 cycles. The failure occurred from rivets 22 through 51 on the lower rivet row, which ruptured the lower skin, as shown in Figures 38 through 40. No tear straps were broken.
